KNVvL Gliding Dept.
KNVvL safety commission (CVZ)

Incident 2020-005

**Failure gear operating mechanism Duo
Discus XLT**

Written by	Ruud Holswider David Hofstee
Document number	OR-I-2020-005-EN
Version	1.0
Publication date	23/07/2020
Clearance	Public / Internal / Confidential

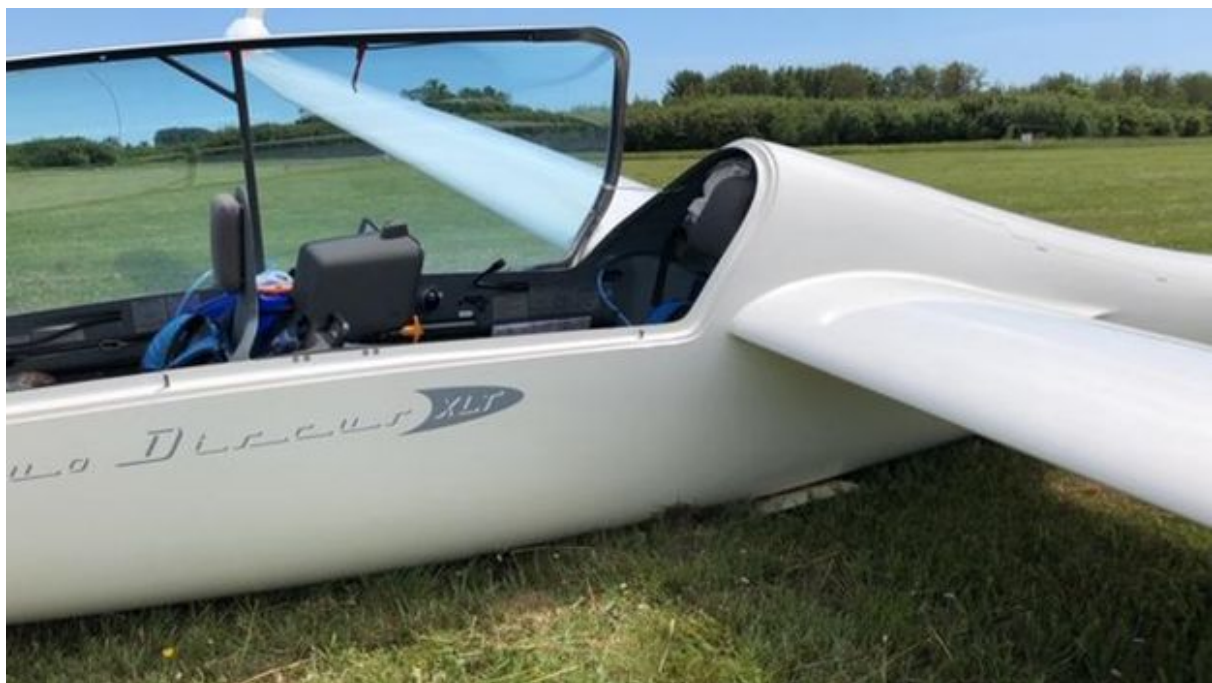
Initial inspection revealed a broken pushrod of the gear mechanism.

The insurance expertise also involved an inspection of the broken pushrod. This inspection revealed a weak welding connection.

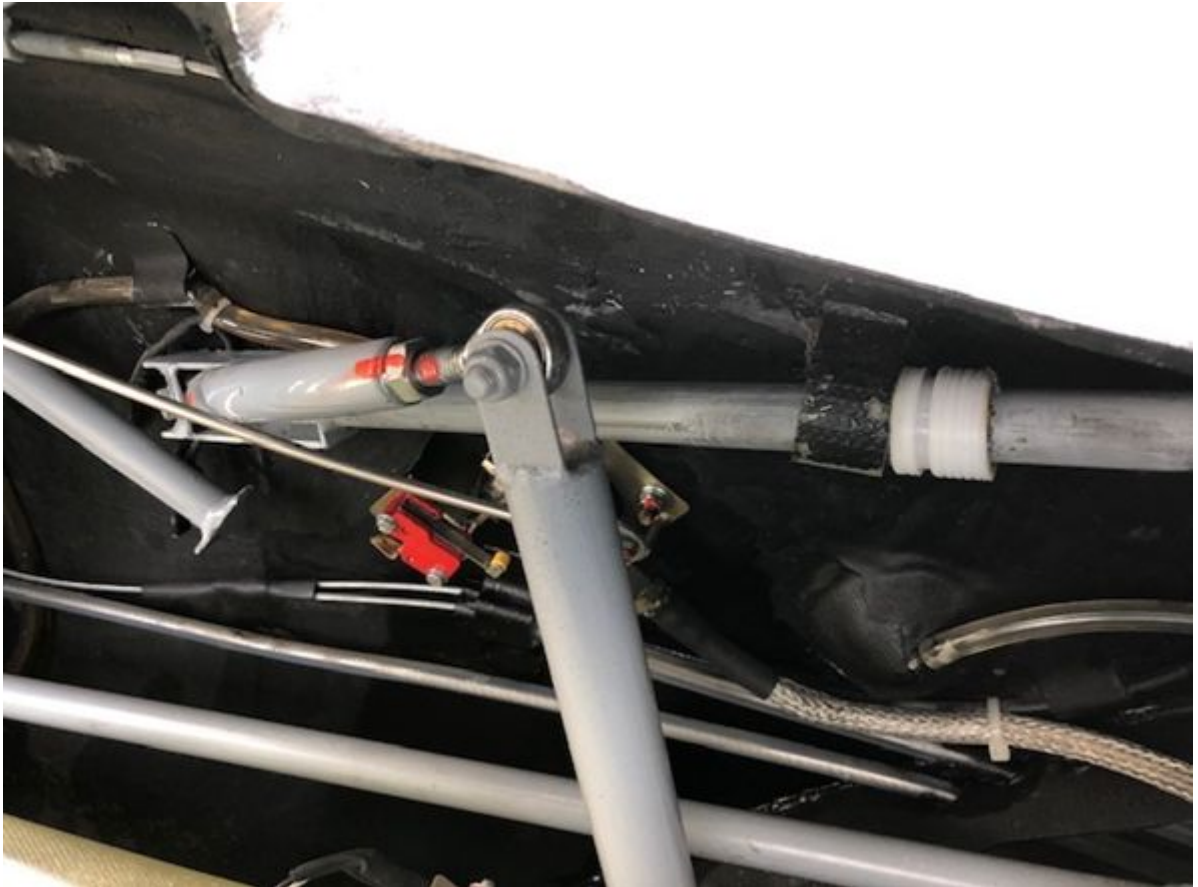
A part of the broken pushrod had also ruptured the fuel line at the fuel shut-off valve, causing a fuel leakage into the fuselage.

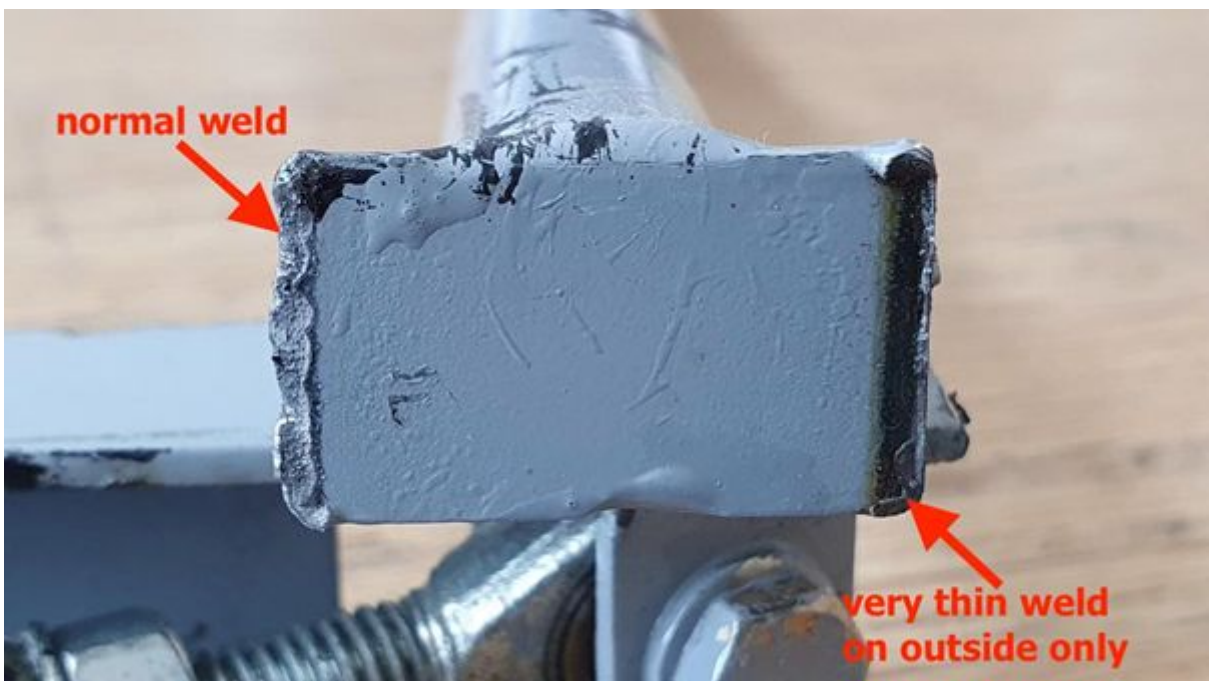
- Before this incident SH has received 2 other notifications on similar cases. These are undocumented.
- SH is not convinced that the weak welding connection was the primary cause of this incident. Insufficient maintenance and /or hard landing(s) could be a contributing factor according to SH.
- In 2013 SH drafted a special welding protocol to prevent reoccurrence.

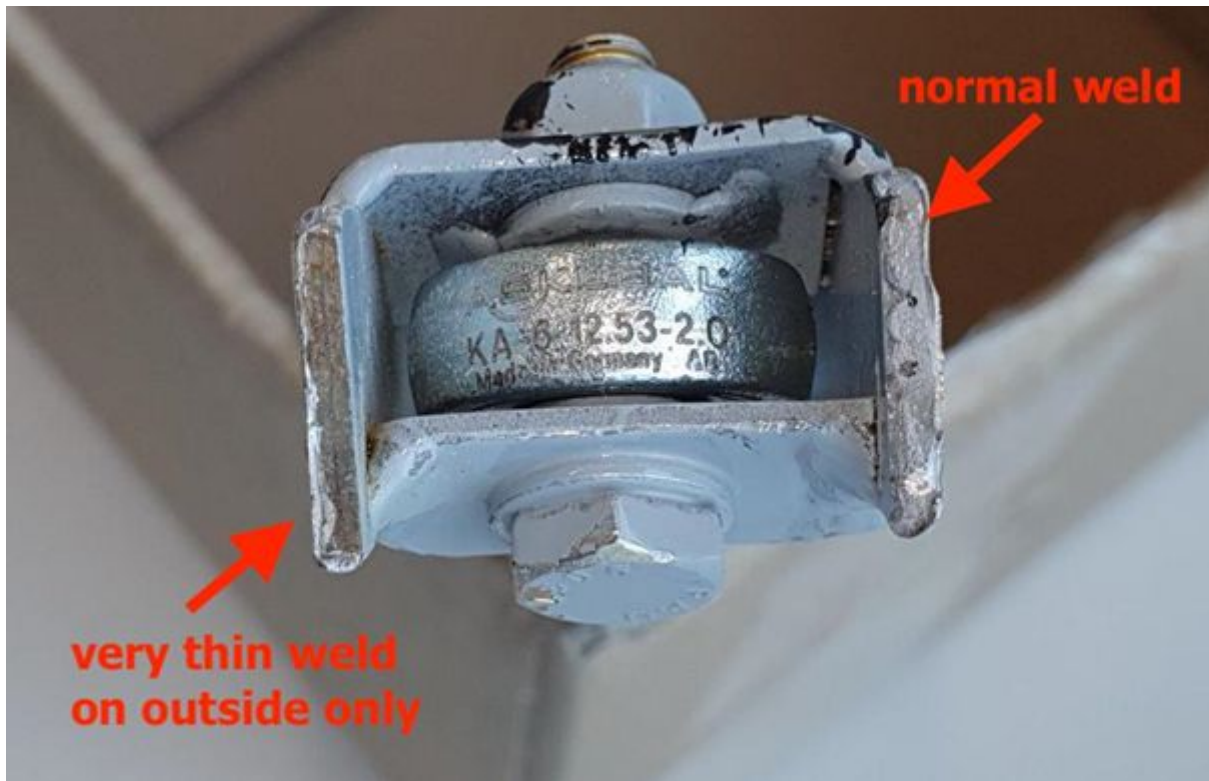
Maybe small cracks in the construction are already visible before failure of the welding connection?

When the wings are removed the area can easily be inspected by mirror or camera via the opening for the wing spar on the right hand side of the fuselage.
