KNVvL Gliding Dept.
KNVvL safety commission (CVZ)

Incident 2020-005

**Failure gear operating mechanism Duo
Discus XLT**

Written by	Ruud Holswider David Hofstee
Document number	OR-I-2020-005-EN
Version	1.0
Publication date	23/07/2020
Clearance	Public / Internal / Confidential

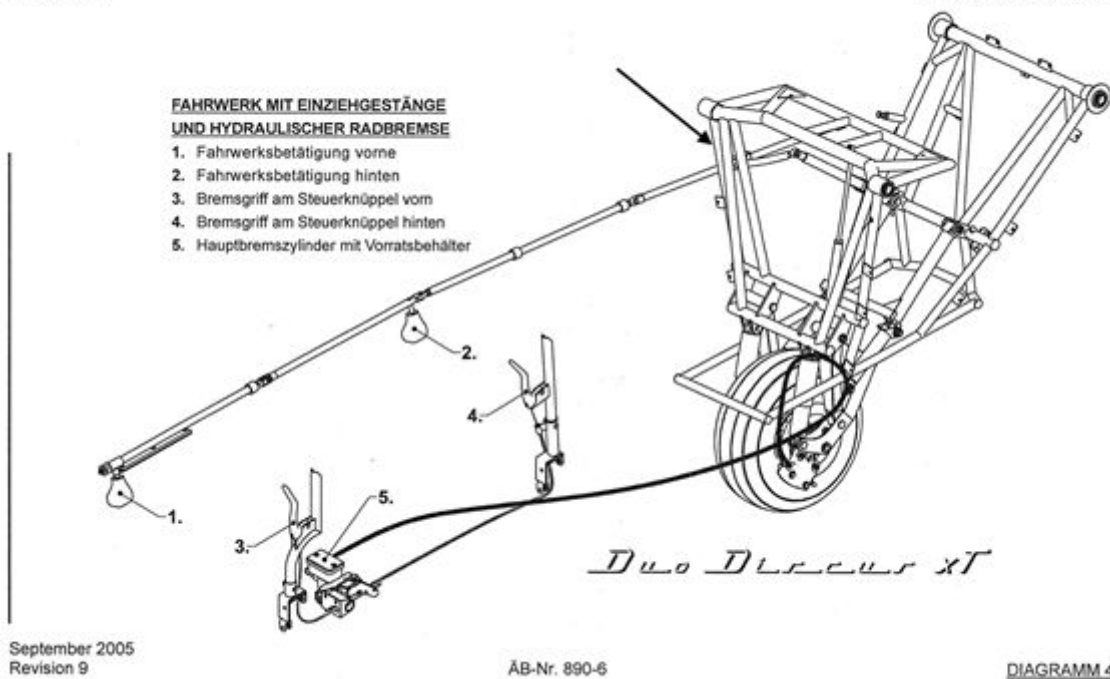
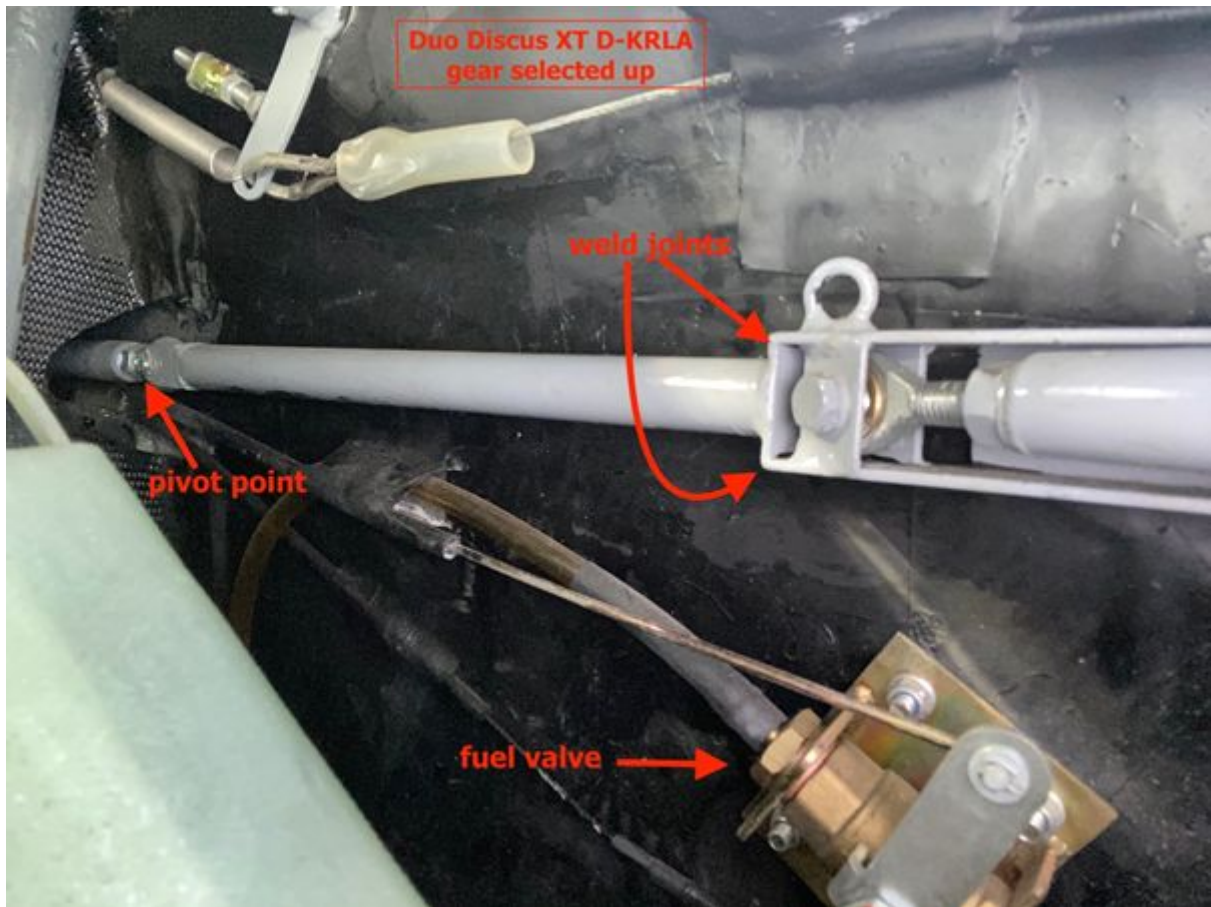
Initial inspection revealed a broken pushrod of the gear mechanism.

A part of the broken pushrod had also ruptured the fuel line at the fuel shut-off valve, causing a fuel leakage into the fuselage.

The insurance expertise also involved an inspection of the broken pushrod. This inspection revealed a weak welding connection.
